ROUMANIA TEST FACILITY

– Church of Satu Mare -

The target: To observe the early streamer emission facing to a simple rod both installed in the same conditions.

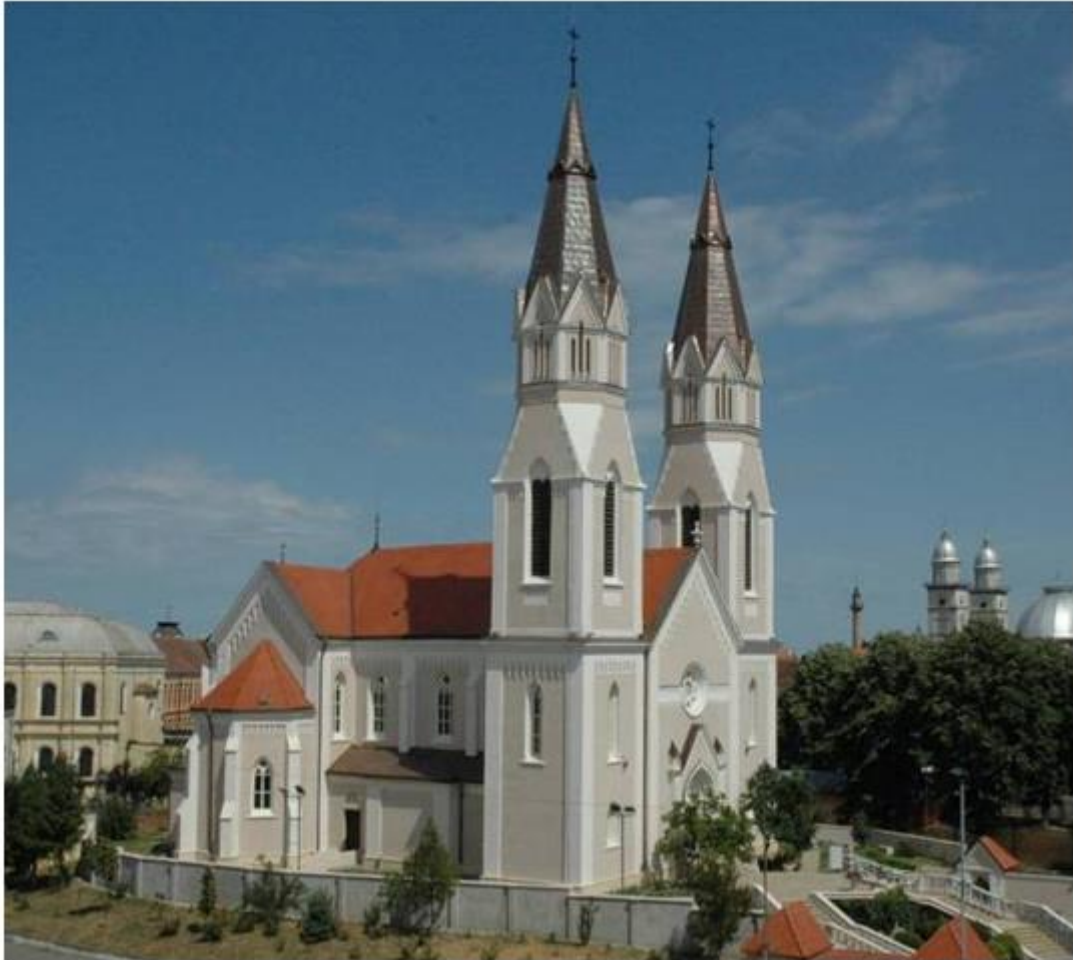
Church of SATU MARE in Romania

The Church of SATU MARE has a length of 38 meters and a width of 22 meters, this religious building consists of two bell towers.

Those two bell towers are 40 meters at its highest point.

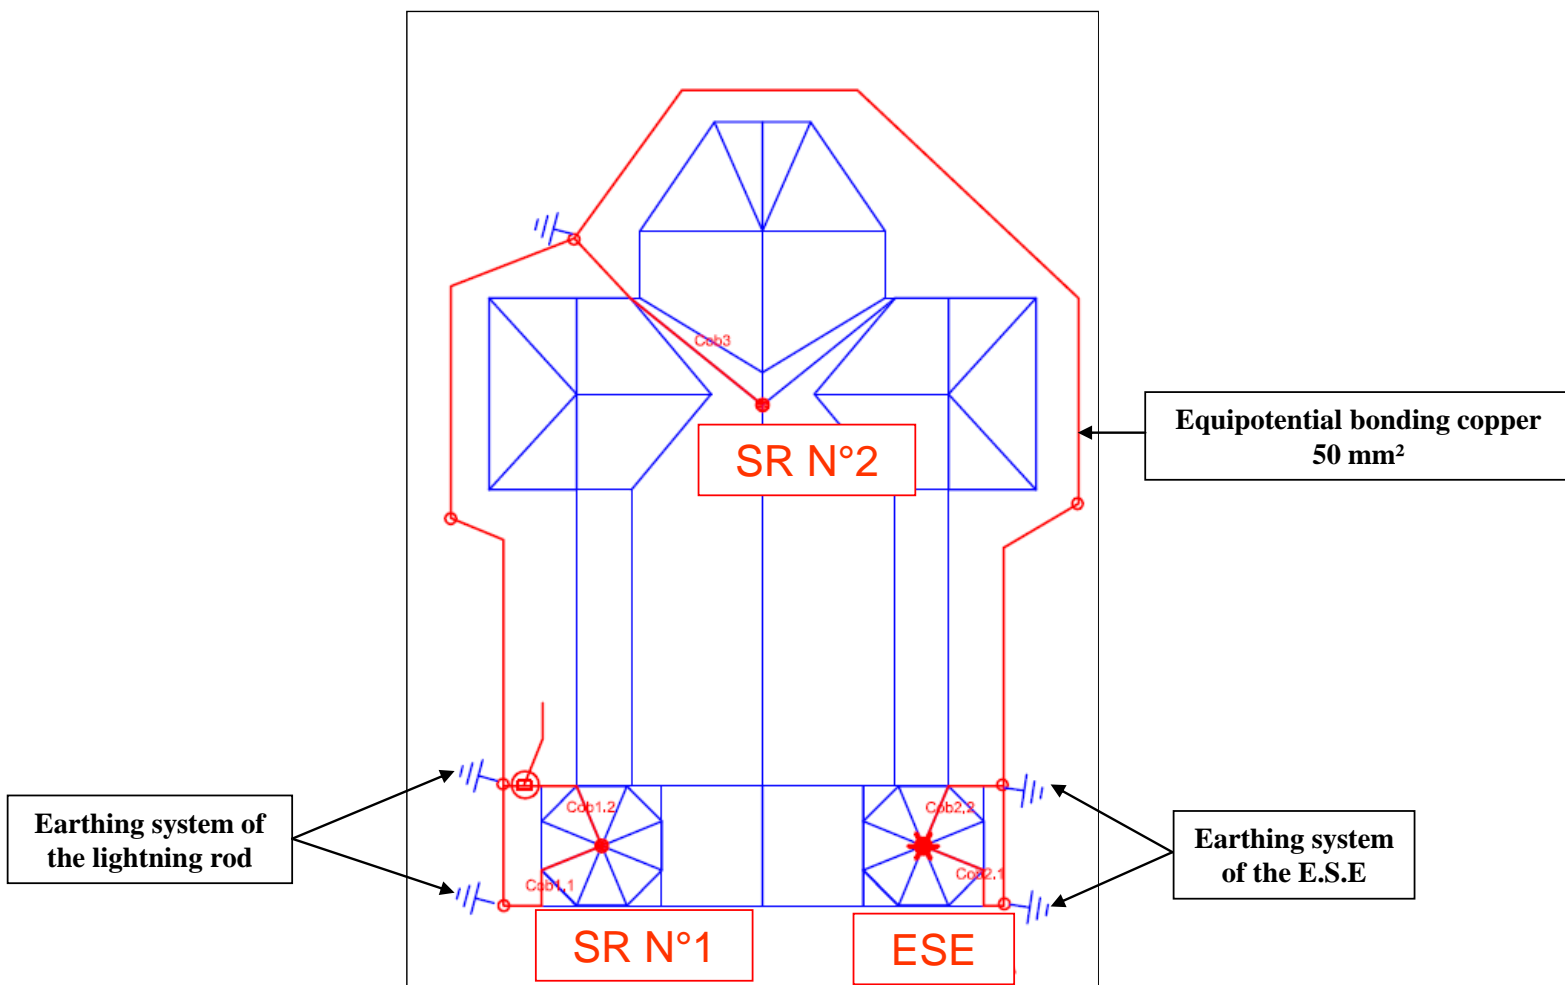
The two bell towers are protected against lightning with two equipments.

- One is equipped with an ESE with an advance time of 45 μ s
- The other is equipped with a lightning rod in 316 L stainless steel in accordance with EN 50164-2.
- A third PTS is located on the nave of the church.

The ESE is installed symmetrically opposite with the PTS (as defined in the NFC 17-102 standard in September 2011). These two protections devices have two lightning down-conductors in tinned copper strip 30x2 mm.

These two protections against lightning are connected to two earth systems of type A «crow's feet».

The earth electrodes are interconnected by an equipotential bonding round of 50 mm². The electrical ground of the church is also connected to the lightning earthing system conductor in copper round 50 mm².

Schematic of the in situ test in Romania

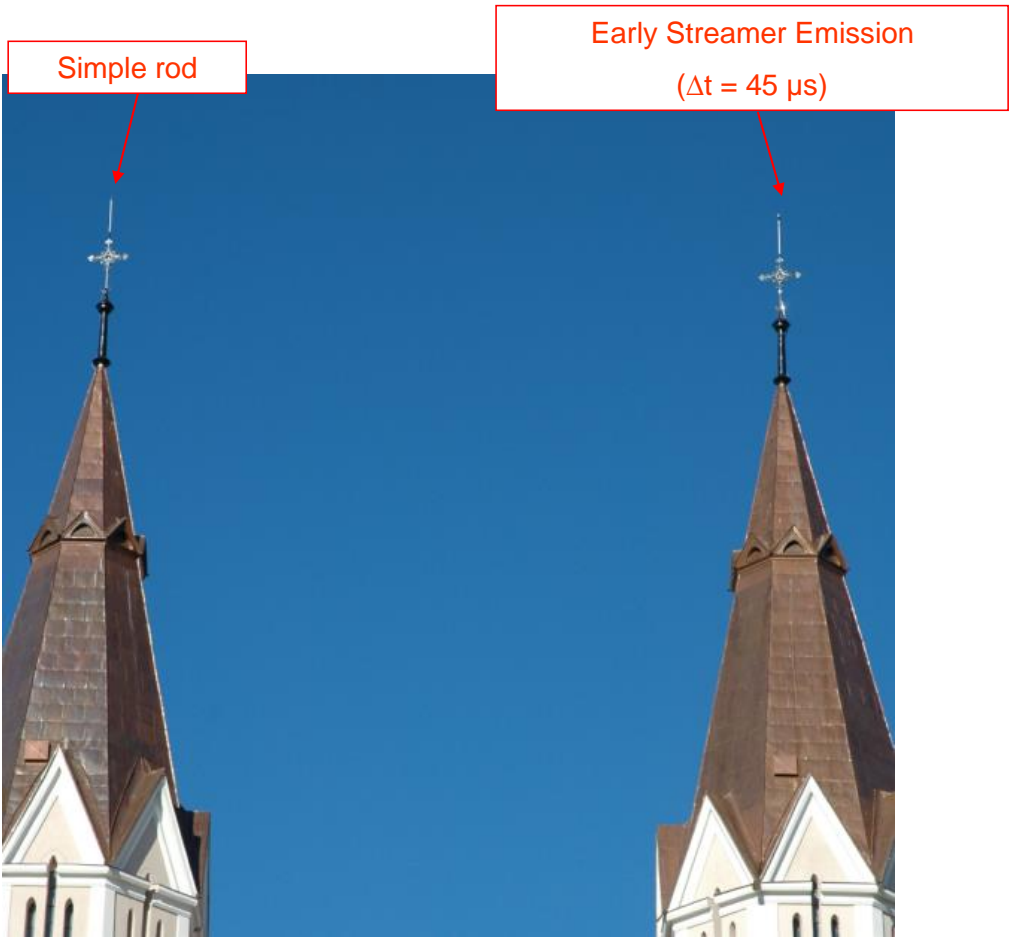
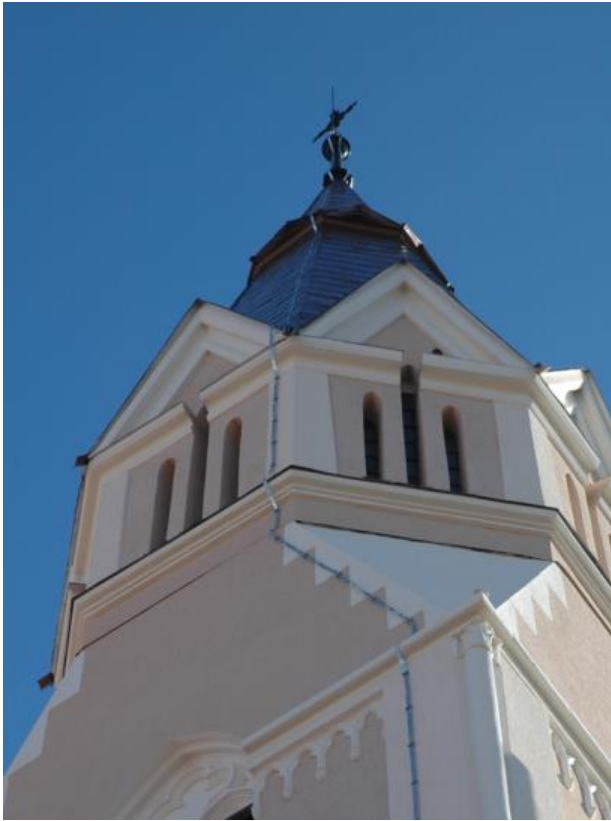
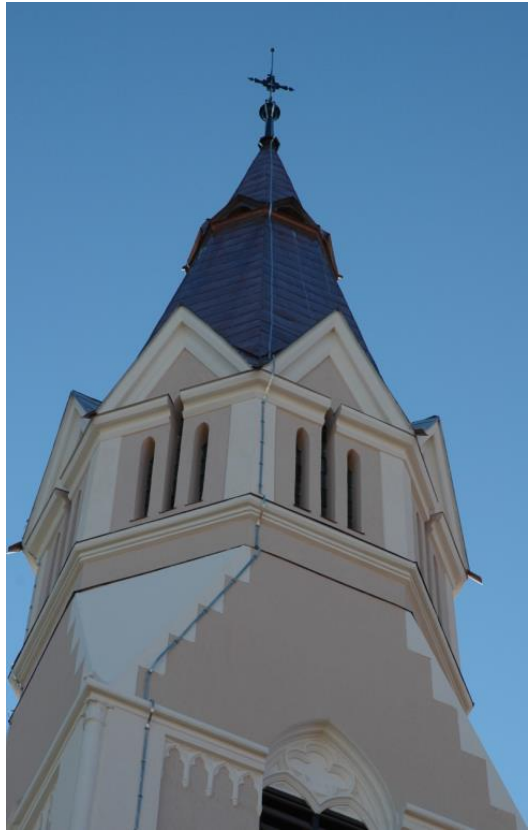
In Situ Test – Church of Satu Mare (Romania)

For each Air-terminal installed:

The bottom part of the down conductor connected the most directly to the earthing system is equipped with a lightning strike counter witch records the lightning events. These lightning strike counters are in sealed boxes.
